## Macroseismic survey and geological investigations following the Al Hoceima (Morocco) earthquake of February 24, 2004

### *Le séisme d'Al Hoceima (Maroc) du 24 février 2004 ; macrosismicité et investigations géologiques*

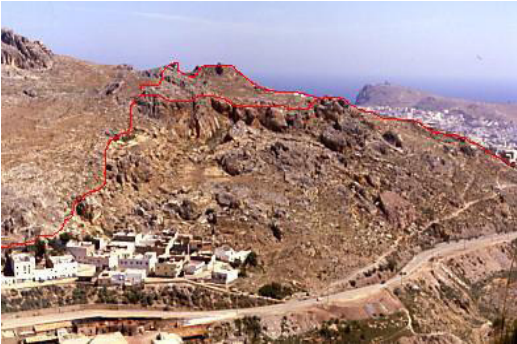
At the O. Mansor site (Picture 1 - Tab. 1), the landslide located at this site was reactivated during the earthquake of February 24, 2004. Numerous limestone blocks of metric dimensions which, by getting detached from the carbonate formations constituting the higher part of the slope, form clusters of rock at the foot of the slope. Some of the detached blocs collapsed in the direction of the slope to reach the road.

<p><i>Picture – 1, Tab. 1</i></p>	<p>The current state of the landslide located at the site of Sidi Mansour after the earthquake of February 24, 2004</p>

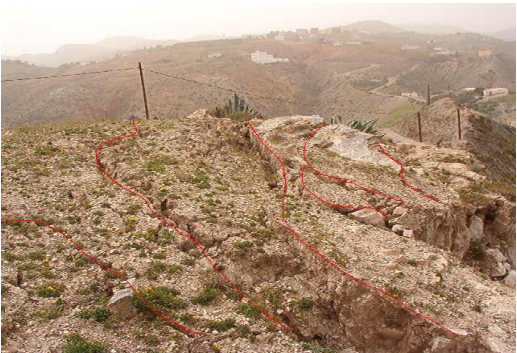
identified as a result of the earthquake of February 2004. Thus, many cracks with a centimetric opening were located at this level. They line-up along N20 to N40 and N60 to N70 directions and affect the upstream portion, where field packets are put in potential imbalance (picture 2 - Tab. 1). Eastward, the permanent movement of this landslide was identified by fissures of about 40 to 50 cm of opening marked on the ground along directions N100 to N110 (picture 3 - Tab. 1). Other elements made it possible to further highlight the reactivation of this landslide such as a stretching of electrical wires intended to supply electricity to the upstream village (picture 4 - Tab. 1).

<p><i>Picture - 2, Tab. 1</i></p>	<p>The recent movement induced by the February 24, 2004 earthquake in the Tala Youssef landslide. Several fresh cracks are tracing upstream and field packets are in potential imbalance.</p>

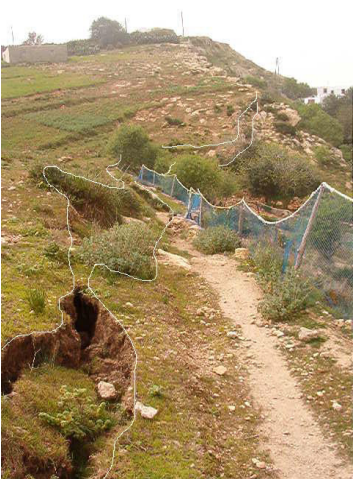
<p><i>Picture - 3, Tab. 1</i></p>	<p>Cracks induced by the recent seismic activity at the Tala Youssef Douar. They have openings about 40 cm to 50cm.</p>

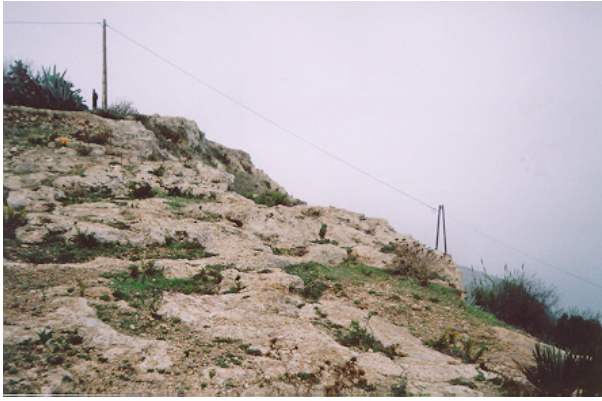
*Picture - 4, Tab. 1*

Landslide in activity indicated by the stretching of the electric wire located at the Tala Youssef Douar.

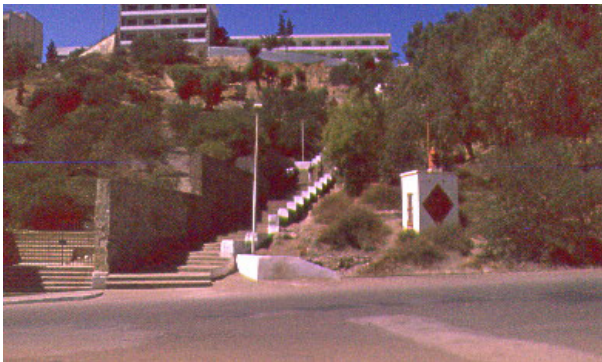
*Picture - 5, Tab. 1*

a momentary stability, such as the Quemado landslide. Apart from the northern and southern parts, the slope vegetation (picture 5 - Tab. 1) has probably contributed to maintain the stability of the site, although our field observations indicate that this stability is rather momentary.

The vegetation has contributed to maintaining stability of the slope in the area of Quemado during the earthquake of 24 February 2004.

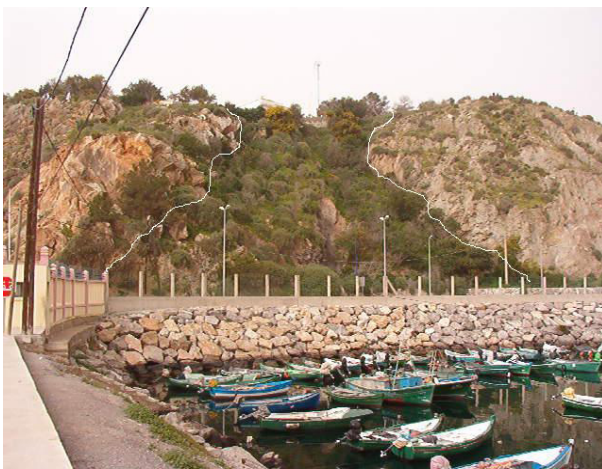
*Picture - 6, Tab. 1*

Similar findings were observed at the port of Al Hoceima. The landslide that developed at this site probably did not react under the effect of the earthquake of February 24, 2004. Also, built constructions at the top the slopes showed no sign of noteworthy damage. Vegetation seems to play an effective stability role (Picture 6 - Tab. 1). Nevertheless, despite this plant protection, cracks develop in the retaining wall built at the foot of the cliff to maintain its precarious balance (picture 7 - Tab. 1).

The recent reforestation of the moving slope in the landslide of the port of Al Hoceima seems to have played the role of effective stability. No remarkable movement indices under the seismic effect have been recorded in this site.

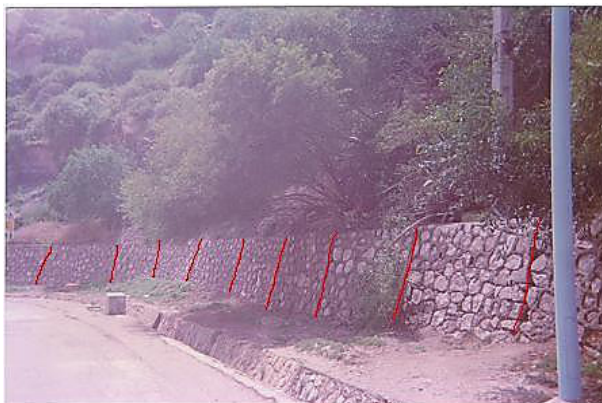
*Picture - 7, Tab. 1*

Cracks in the retaining wall built at the foot of the slope to maintain stability. They attest to the continuous sliding movement of land at the port of Al Hoceima.

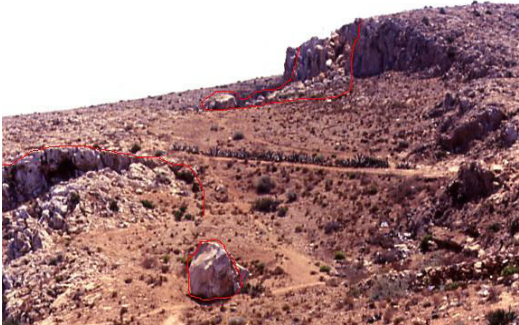
In the area of Cala Bonita, which is a site marked by a permanent ground movement, the seismic shaking was quite felt at this site. At the time of the earthquake of February 24, 2004, several rockslides were triggered (picture 1- Tab. 2). Ground masses, in which distinguished facies of the different units marking the lithostratigraphy at this location, were moved in the direction of the slope until reaching the sea (picture 2 - Tab. 2). Also, fissures and cracks were noticed in massive gray dolomites upstream of the slope (picture 3 - Tab. 2).

<p><b>Picture - 1, Tab. 2</b></p>	<p>The Cala Bonita landslide showing local rockslides, triggered under the effect of the recent seismic activity recorded in the region of Al Hoceima.</p>

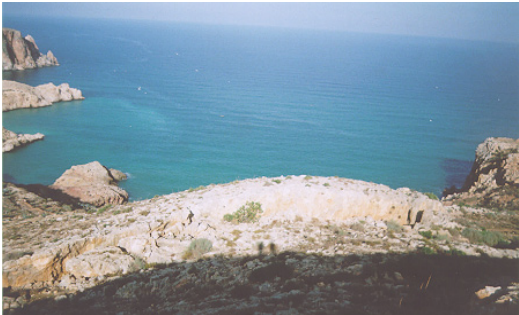
<p><b>Picture - 2, Tab. 2</b></p>	<p>In the Cala Bonita area, we noticed that the seismic activity has caused an imbalance of large ground masses.</p>

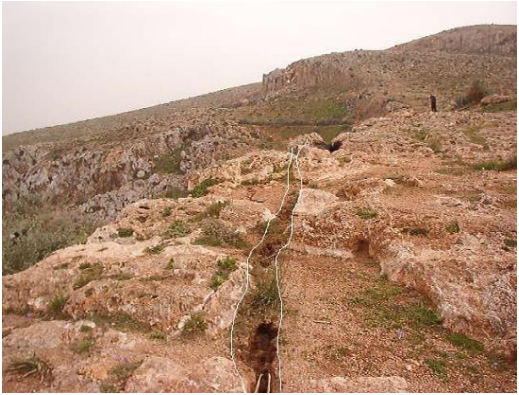
<p><b>Picture - 3, Tab. 2</b></p>	<p>About 10 to 15 cm-wide open fissures in the ground triggered upstream of the slope following the earthquake of 24 February 2004 in the Cala Bonita landslide.</p>

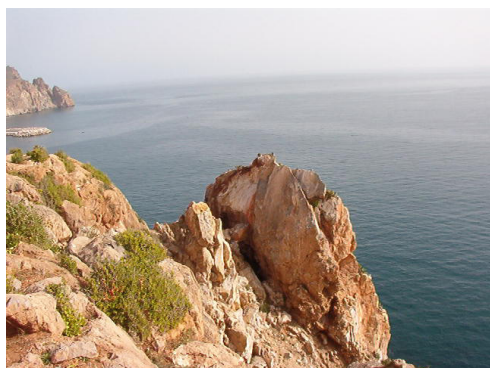
**Picture - 4, Tab. 2**

of seismic loading. In the area displaying potential indices of movement, several fissures were identified. The earthquake of February 24, 2004 triggered rock-falls of metric to pluri-metric dimension. Field observations carried out in this sector made it possible to note the freshness of the markers of these land instabilities (picture 4 - Tab. 2).

Detached limestone blocks following the February 24, 2004 earthquake in the Moro Jievo area on the east of Al Hoceima.

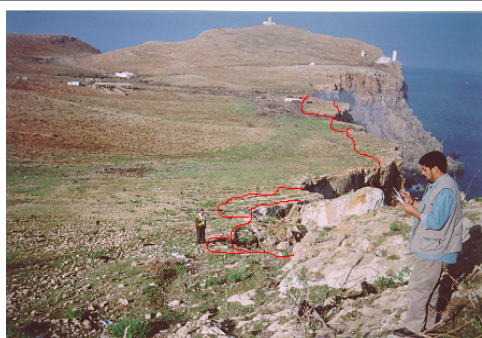
**Picture - 5, Tab. 2**

North of the city of Al Hoceima, in the area of Ras El Abed, field visits made after the main shock allowed us to witness the impact of seismic activity on the geological environment. Many substantial fissures subsequent to this seismic event appeared along the cliff (pictures 5 and 6 of Tab. 2). In places they show openings of 30 to 50 cm and are aligned in the directions N120 to N130 and N150 to N160.

Fissures that appeared in the limestone of Ras El Abed. They were triggered following the earthquake of February 24, 2004, following directions between N120 to N130 and N150 to N160.

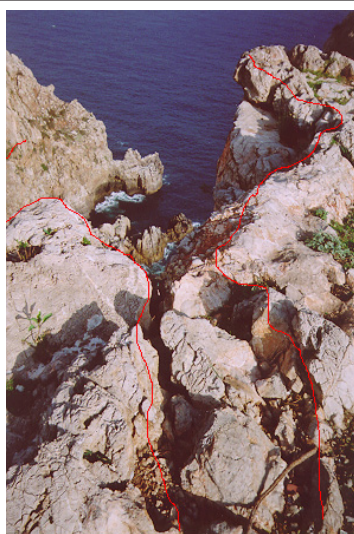
**Picture - 6, Tab. 2**

Fissures in limestones located in the Ras El Abed sector, triggered following the earthquake of February 24, 2004. They show openings of about 30 to 50 cm.

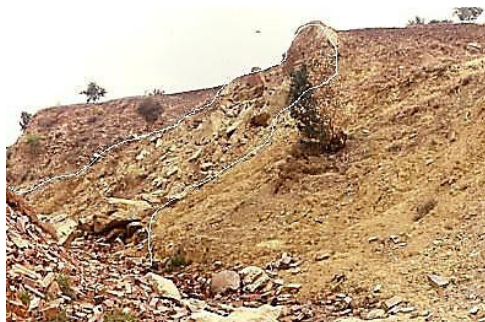
**Picture - 7, Tab. 2**

South of Al Hoceima, along the Isli River, the Rockslides were located in Tertiary flysch rock formations (picture 7 - Tab. 2). These ground movements were triggered under the seismic effect in the muddy landslides that developed in these formations under the effect of precipitation.

Rockslides triggered downstream of the Isli River following the recent seismic activity recorded in the region of Al Hoceima.

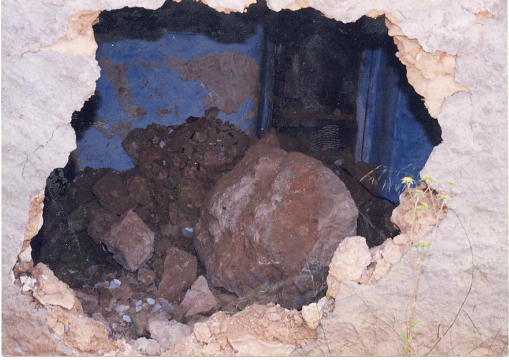
Indeed, metrics boulder caused, after covering a distance of about 20 m, the destruction of the wall of a house in the village of Izemmourène, southeast of Al Hoceima (picture 1 - Tab. 3). Also, a boulder rolled down from the top of the hill to the road at Izafzafène (picture 2 - Tab. 3).

<p>Picture - 1, Tab. 3</p>	<p>Effect of the phenomenon of Rockfall triggered as a result of seismicity. The wall of the house was destroyed by a boulder at Izemmourène.</p>

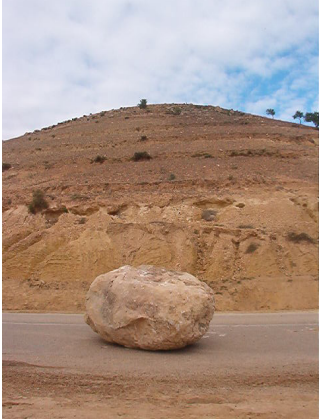
<p>Picture - 2, Tab. 3</p>	<p>Boulder fell from the top of the hill during the earthquake of February 24, 2004 in the area of Izefzafène.</p>
